# AIRBORNE THERMAL INFRARED REMOTE SENSING

## UPPER GRANDE RONDE RIVER BASIN • OREGON

( SURVEY DATE - 8/7-12/2010 • REPORT DATE - 12/13/2010 )

**COLUMBIA RIVER INTER-TRIBAL FISH COMMISSION**

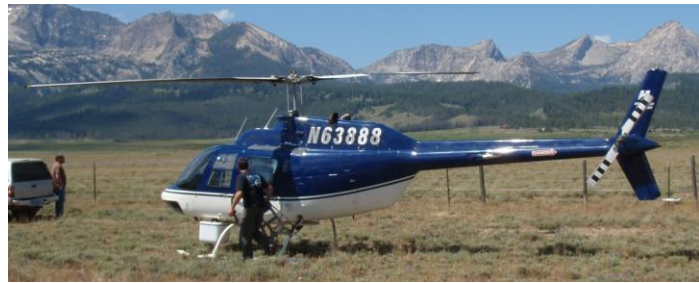
*Figure 2. Bell Jet Ranger equipped with a thermal infrared radiometer and high resolution digital camera. The sensors are contained in a composite fiber enclosure attached to the underside of the helicopter which is flown longitudinally along the stream channel.*

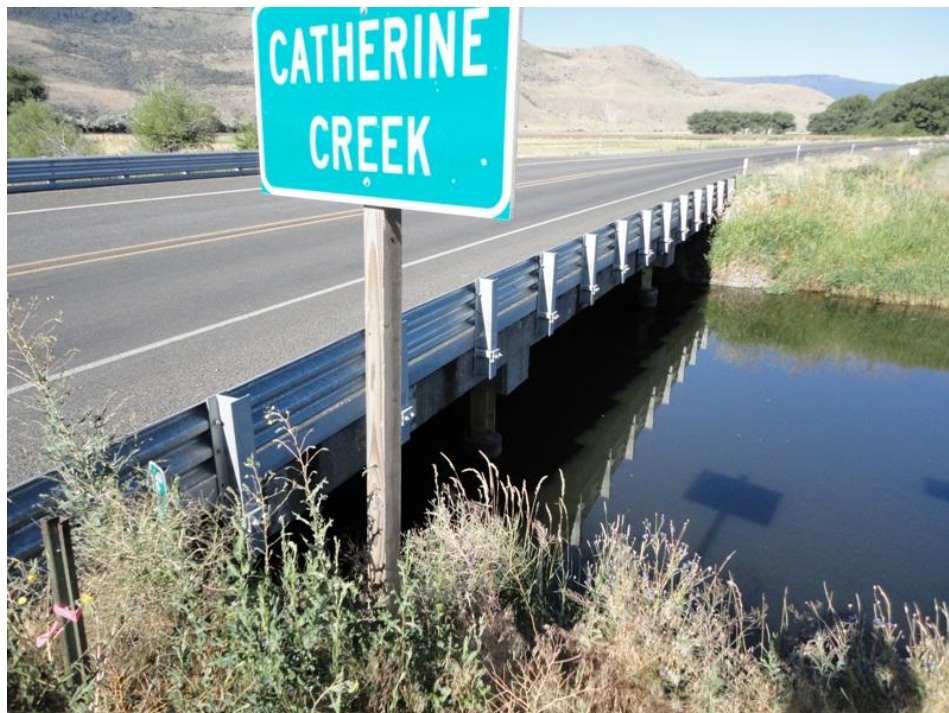
The Upper Grande Ronde River and its tributaries are discussed first, followed by Catherine Creek and its tributaries, with the major focus being on the longer streams in the study area. The sample images contained in this report are not meant to be comprehensive, but to provide examples of river features and interpretations. Color ramps in the sample images are unique for each stream.

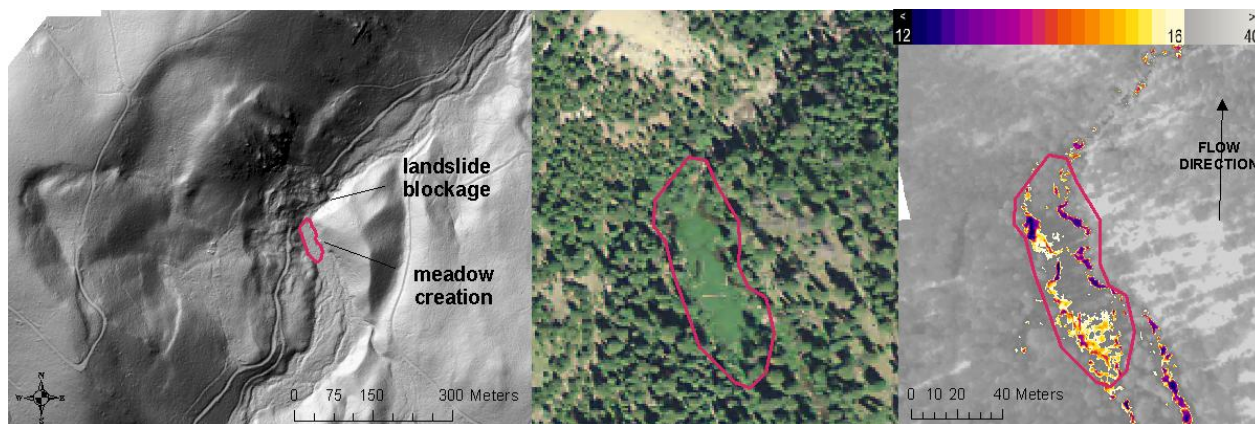
*Figure 19. The bare-earth LiDAR/NAIP/TIR image below shows the landslide and meadow complex at river mile 1.74.*
